TENNESSEE VALLEY AUTHORITY
WATER CONTROL PLANNING DEPARTMENT

REPORT NO. O-3075

FLOOD CONTROL
FOR
UPPER FRENCH BROAD RIVER
AND
TRIBUTARIES

A PRELIMINARY REPORT

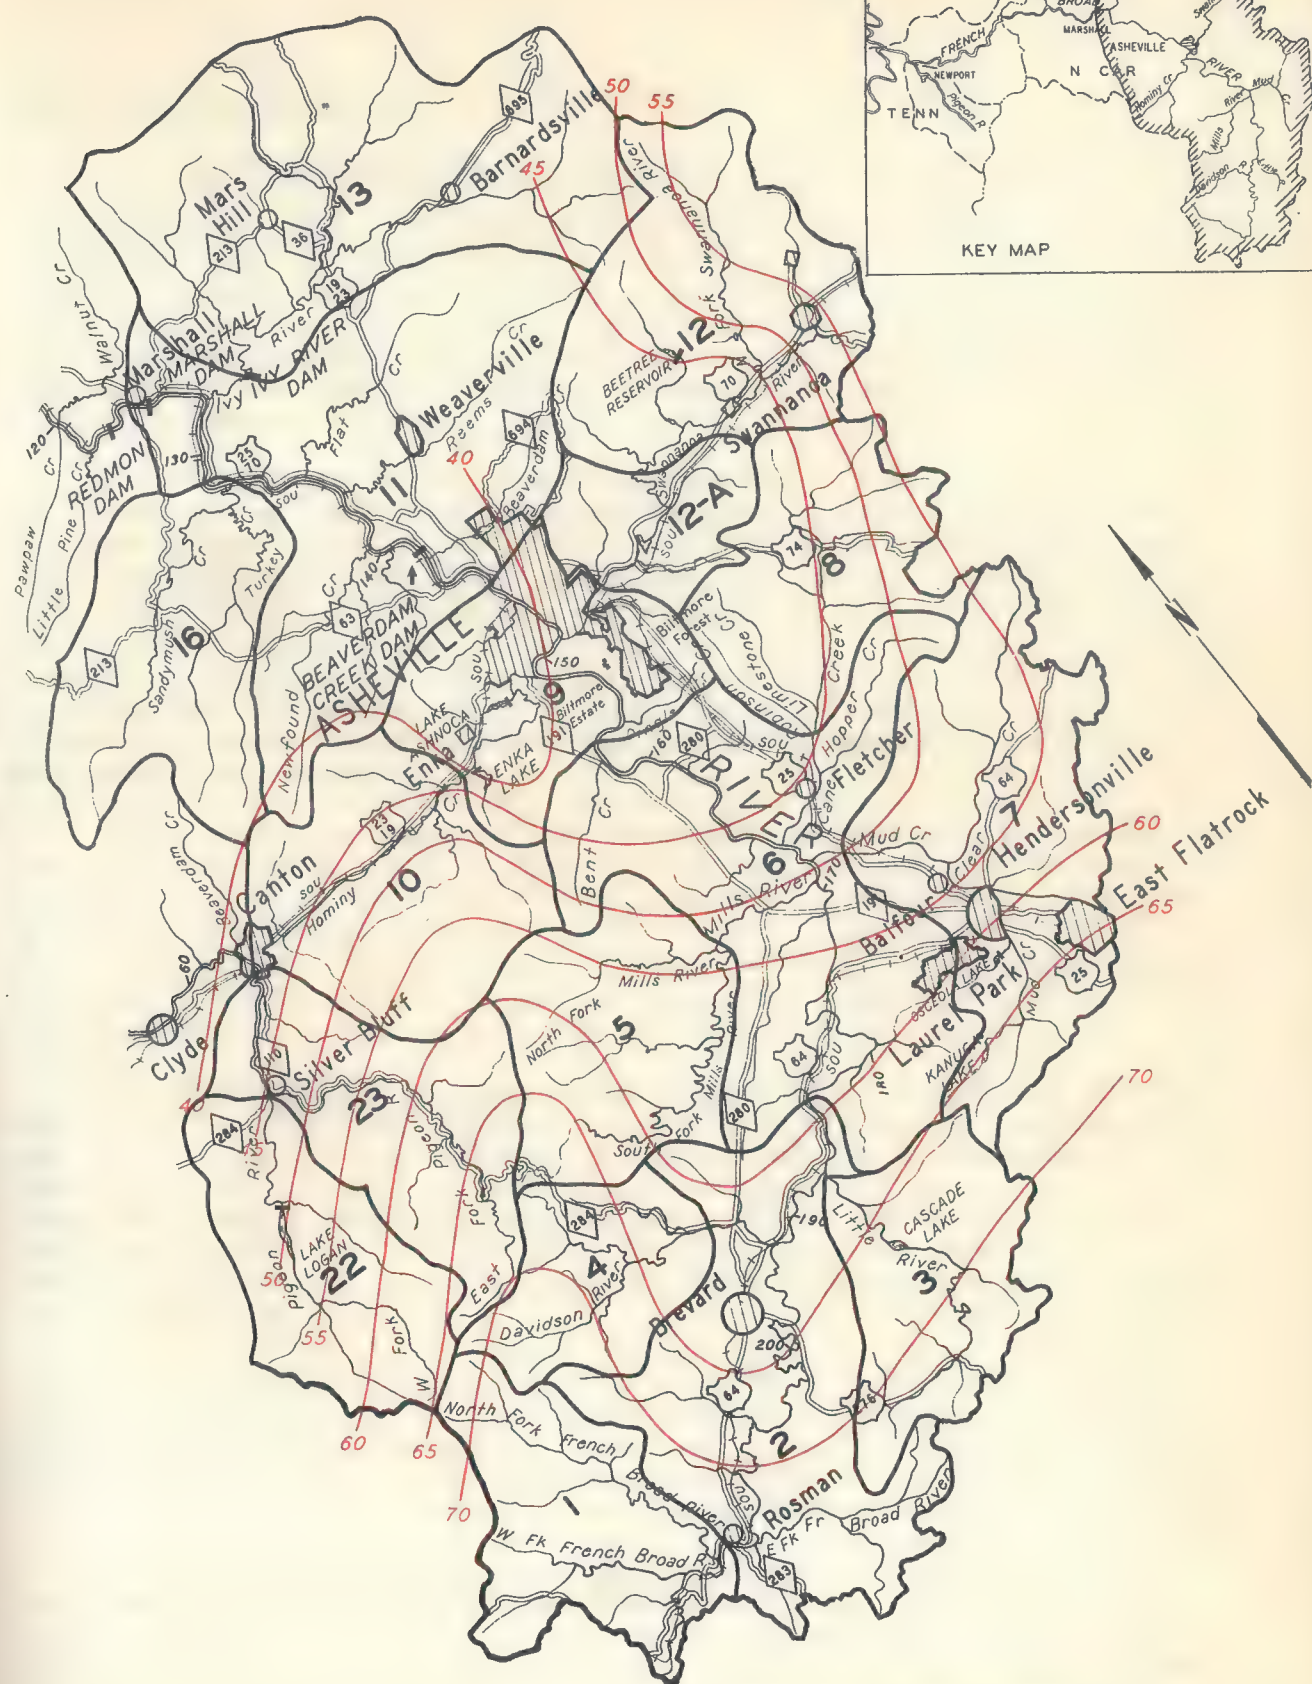
TENNESSEE VALLEY AUTHORITY
 WATER CONTROL PLANNING DEPARTMENT
 UPPER FRENCH BROAD AREA
 SHOWING
 AVERAGE ANNUAL RAINFALL

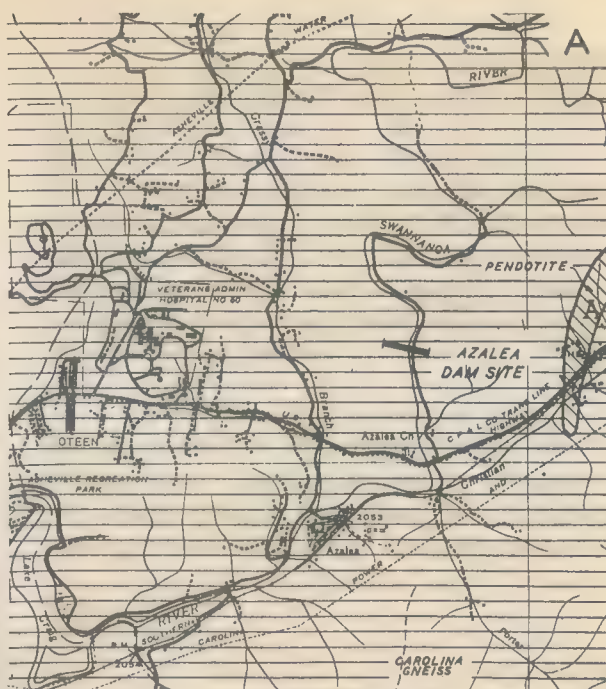
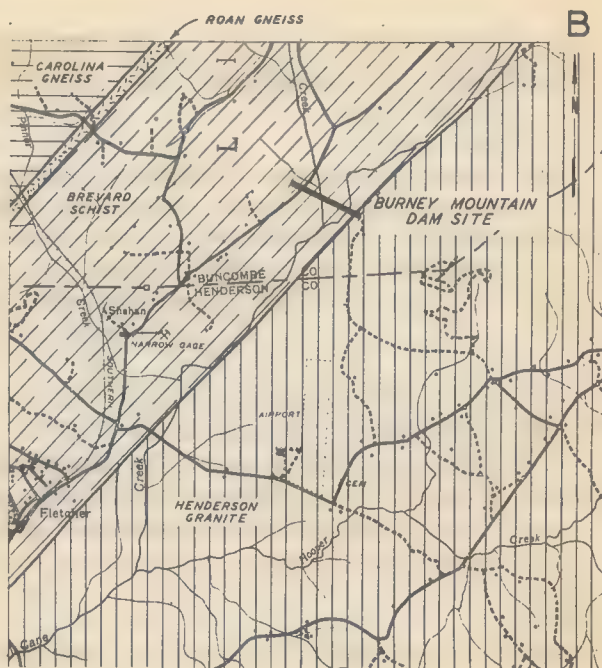
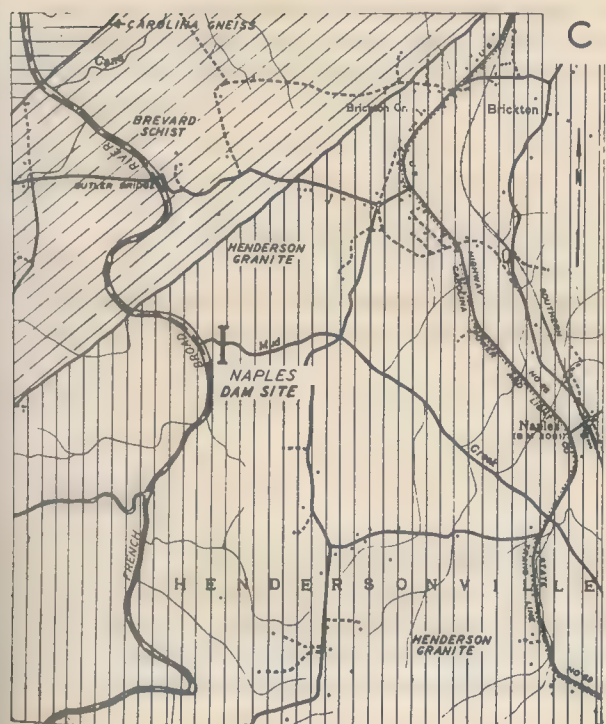
TENNESSEE VALLEY AUTHORITY
WATER CONTROL PLANNING DEPARTMENT
GEOLOGY OF DAM SITES
UPPER FRENCH BROAD BASIN

Joints are extensively developed in the Henderson granite. A majority of them have northeast strikes (N 50° to 60° E) and southeast dips of about 75 degrees. Another set of joints has a trend of about N 10° W, and is vertical, or essentially so.

From the left margin of the flood plain up to an elevation about a hundred feet higher, the left abutment is quite steep. Exposures of bedrock occur along the base of the cliff and on the abutment up to a point about 50 feet higher. The earth overburden is thin, and it is unlikely that there is any appreciable thickness of decayed rock.

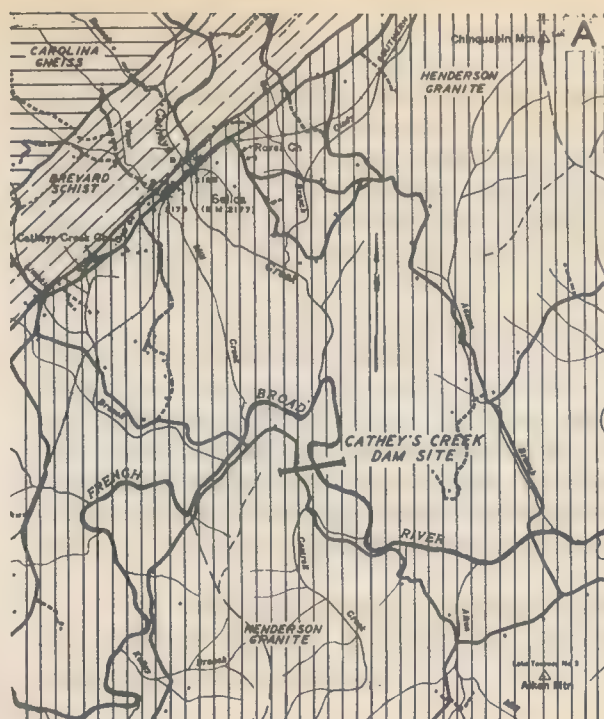
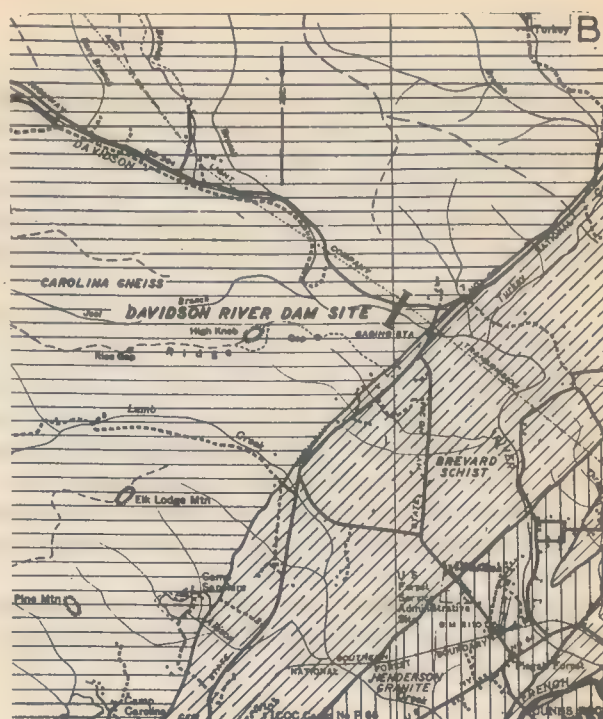
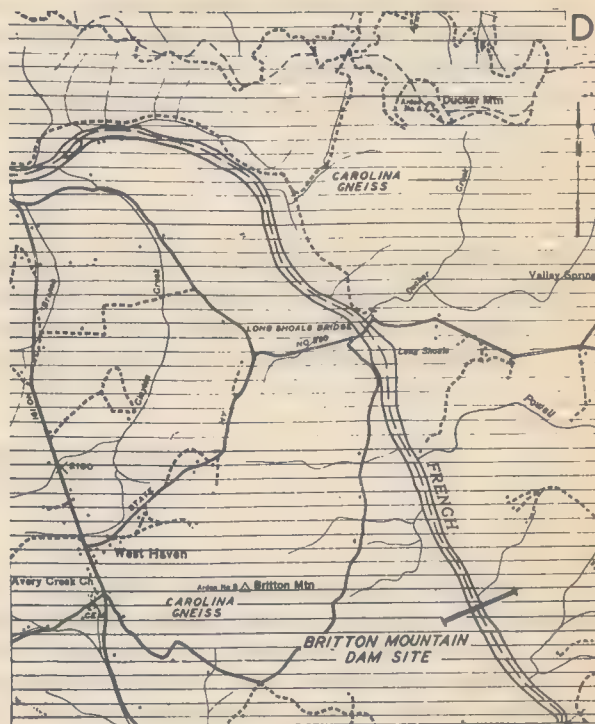
GEOLOGY OF DAM SITES UPPER FRENCH BROAD BASIN

The dam site (No. 1) is in the middle section of a sigmoidal curve in the stream's course. The river is flowing on bedrock. The right abutment is a steep, but not precipitous, heavily wooded slope which ascends to an elevation of about 100 feet. Bedrock is covered by an undetermined thickness of residual material and talus. The left abutment is separated
